# A Rehabilitation Story Lowman Hall - South Carolina State University – Orangeburg, South Carolina

Alfred A. Lindsay, AIA NCARB, Architect (SC State Campus Architect)
Associate Director, Office of Planning & Construction
South Carolina State University
803-516-4853

John McLean, AIA LEED AP (Project Architect)
Watson Tate Savory Liollio Architecture
1316 Washington St. Columbia, SC
803-799-5181
jmclean@wtsliollio.com

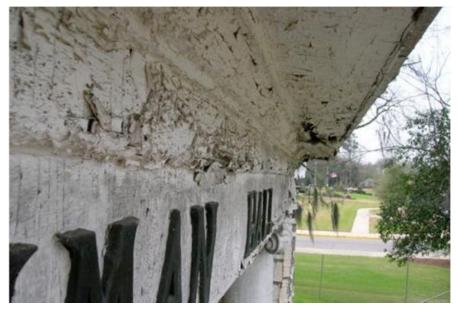
Weathering & Settling

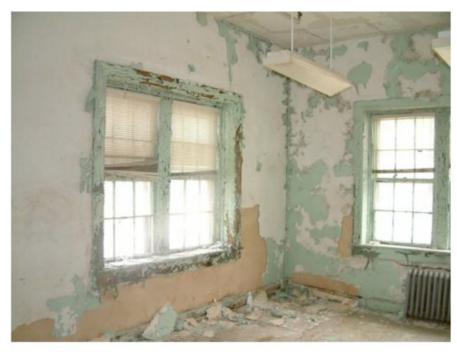
Damage During Closure – Steam Leaks

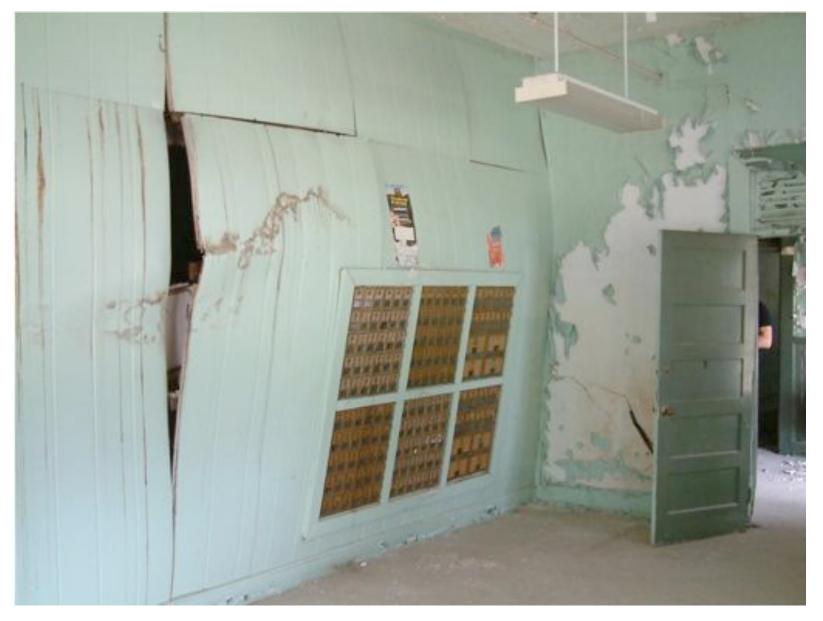
Guess what caused this wall to fail this way.

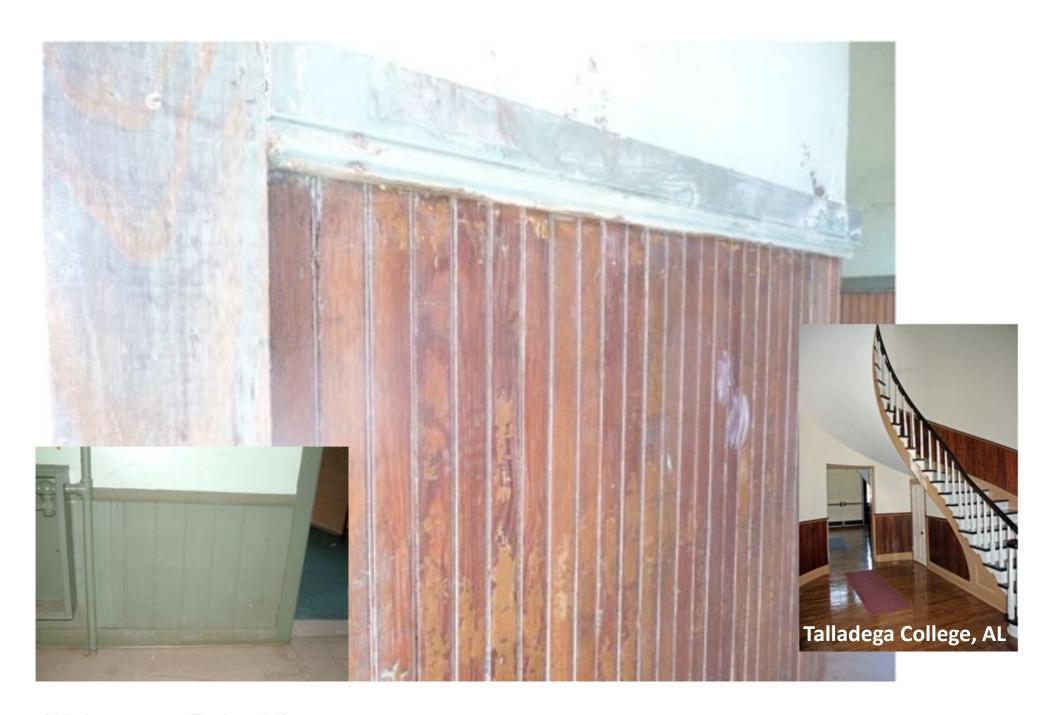
**Wainscot – Paint History**

Guess paint history of trim.

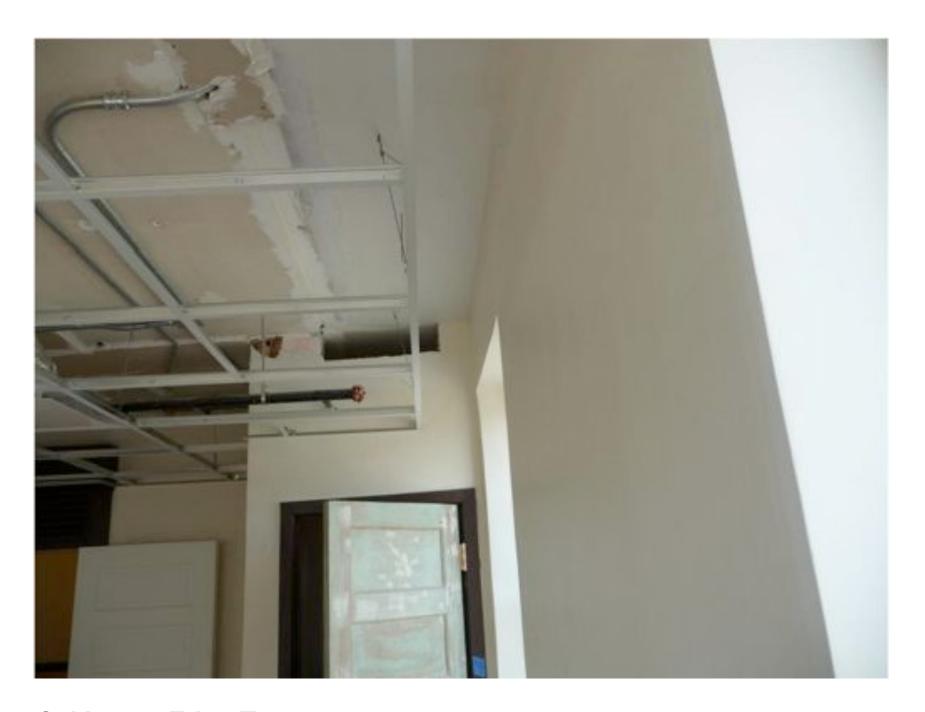
**Ceilings – Discovered Unsoundness**

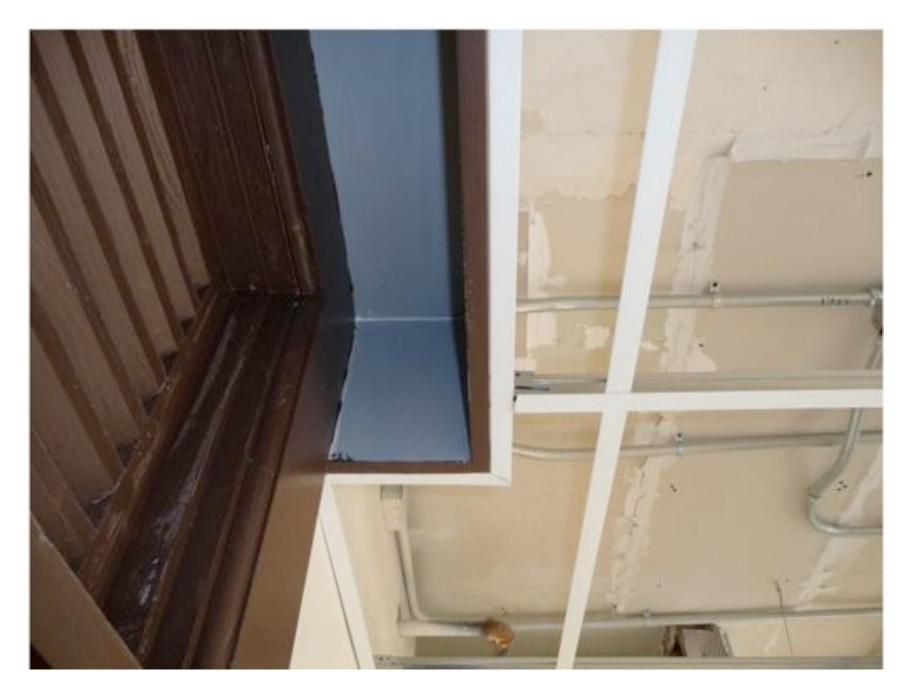
**Ceilings – Edge Treatment**

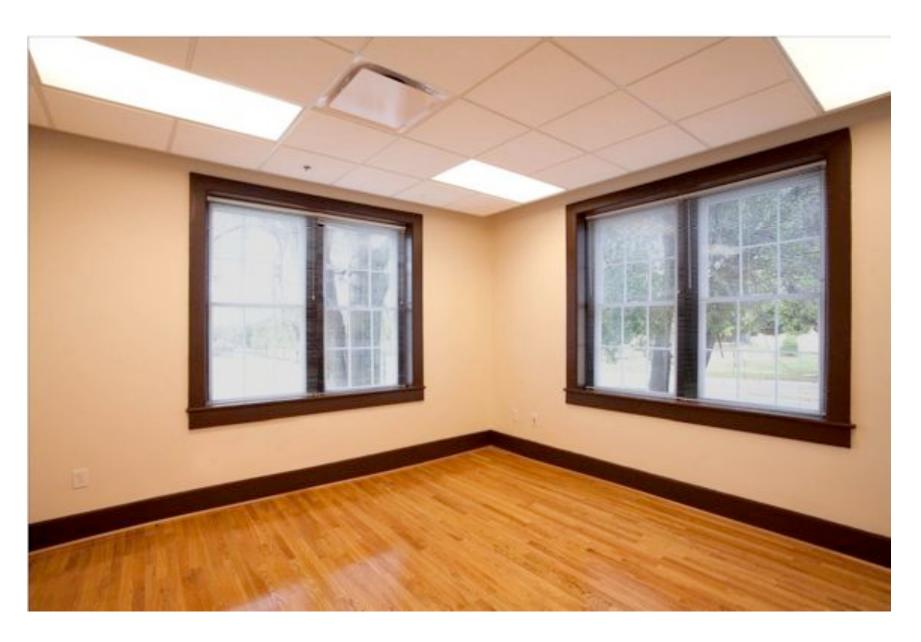
**Ceilings – Edge Treatment – Second Floor Transoms**

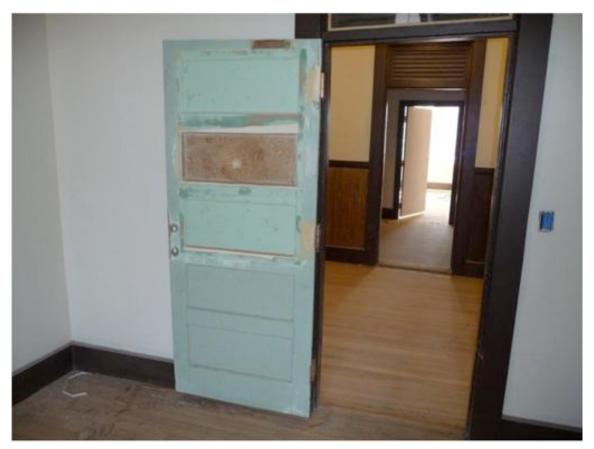
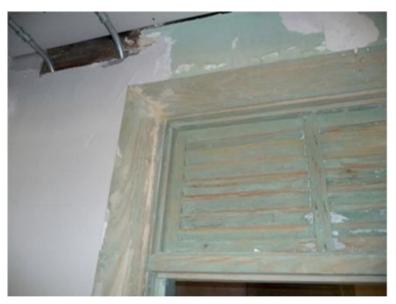
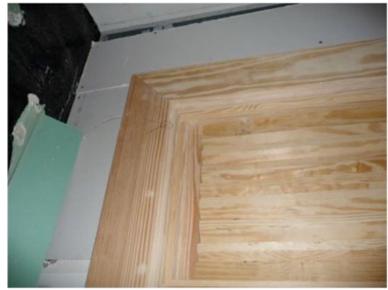
# **Doors and Transoms**

Repair and Replace In-Kind

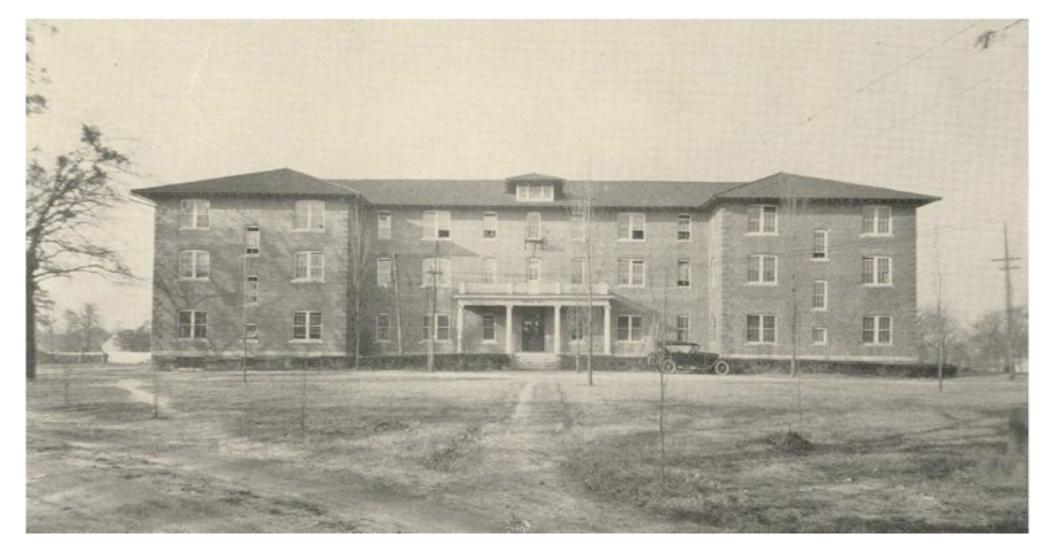
**Roof – Historical Research – Sanborn Maps**

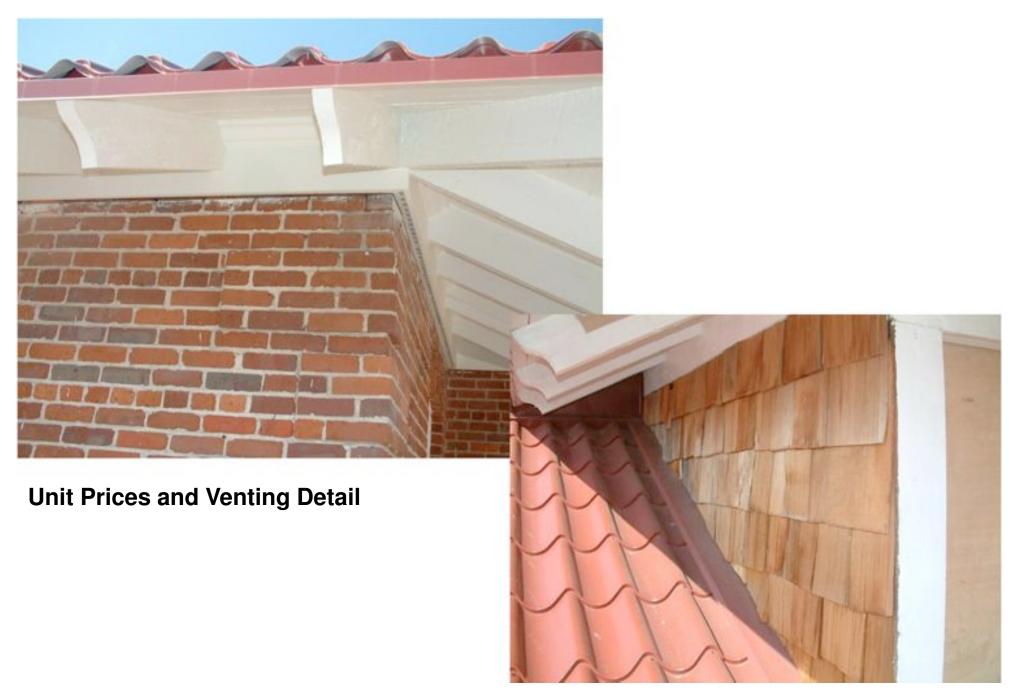
## Metal was chosen over slate for the following reasons;

- 1. Search of attic revealed no evidence of original slate roofing
- 2. Structural engineer felt original framing wouldn't support slate roofing
- 3. Profiled metal roof tiles were available at the time of original construction

- 4. Metal would've been more in line with institution's financing at the time
- 5. Historic photos were non-conclusive

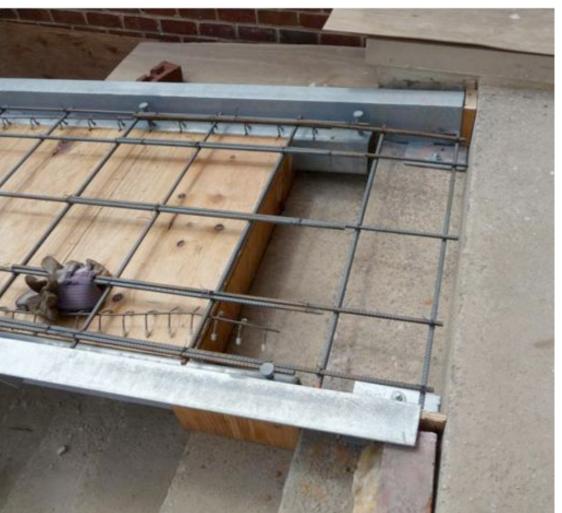
Ramp – Light Touch and Reversible

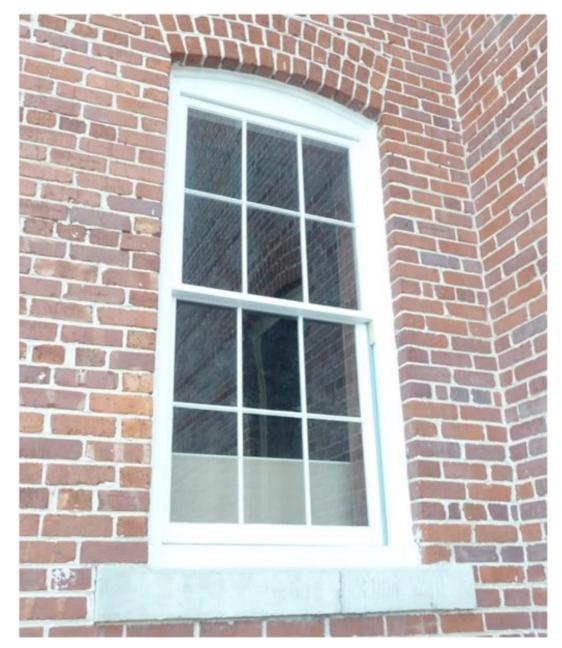
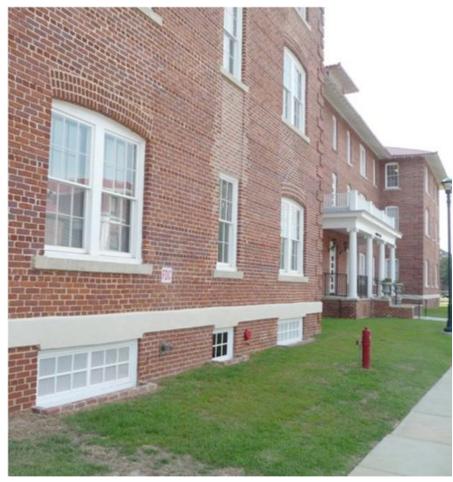
Windows – Restored with Interior Storms

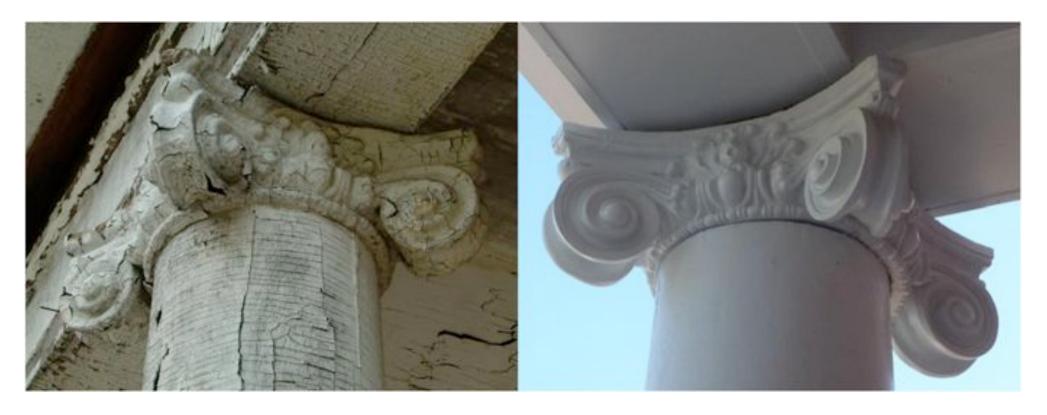
Plaster Column Capitals – Parts Used to Make Mold & Preserve Record

**Before** (capital in best condition)

After (eight new capitals)

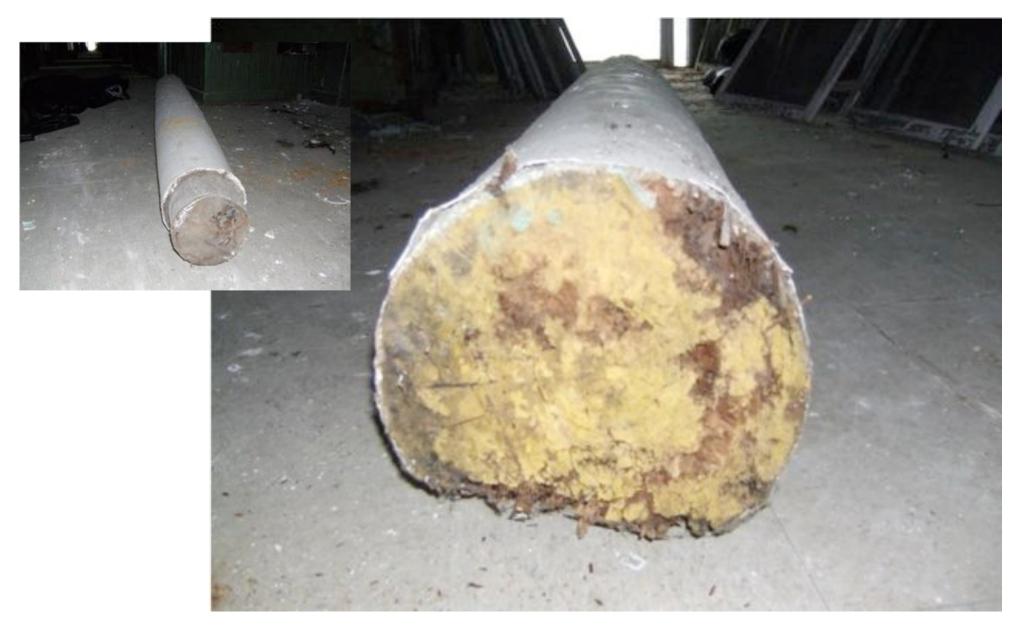
**Wood Columns – Existing Conditions**

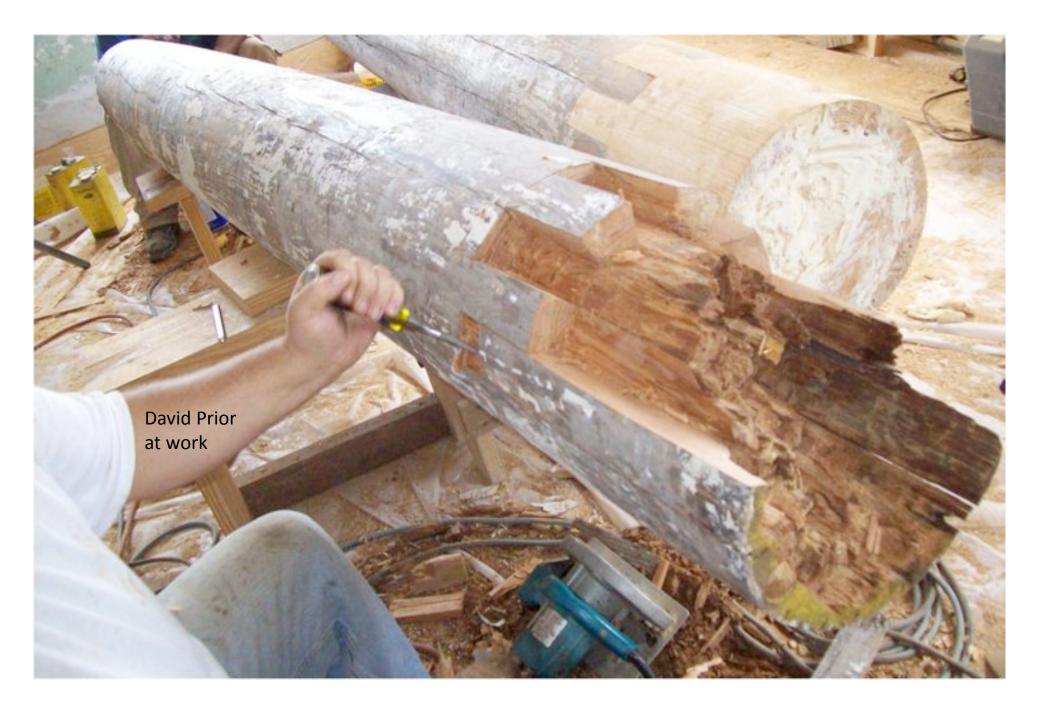
**Wood Columns – Chisels and Staves**

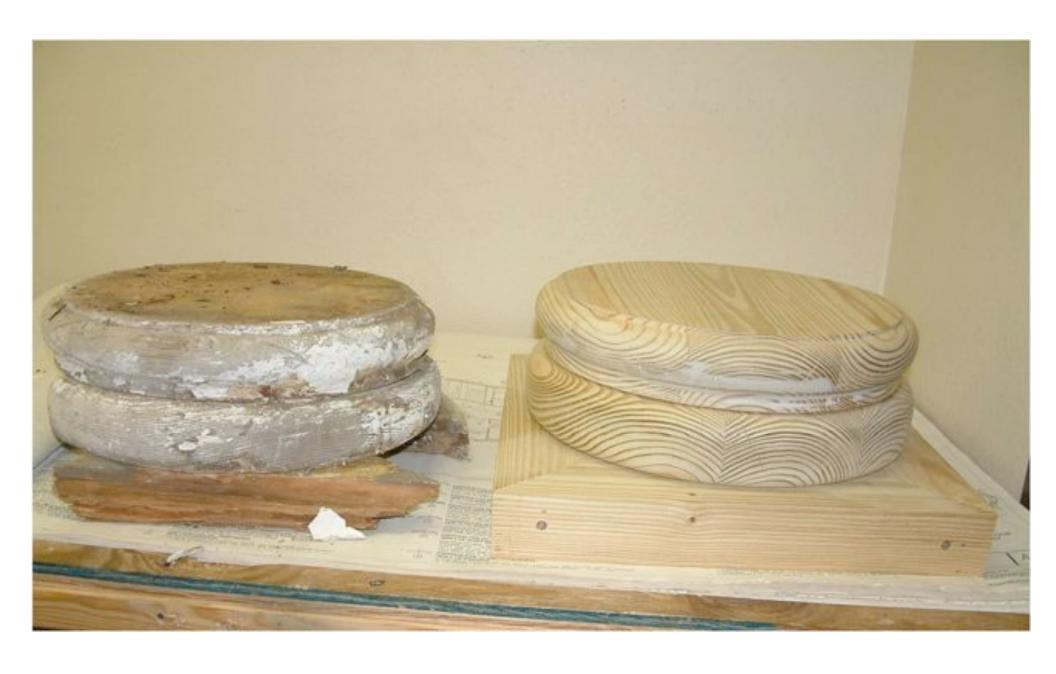
#### **Wood Columns – Bases**

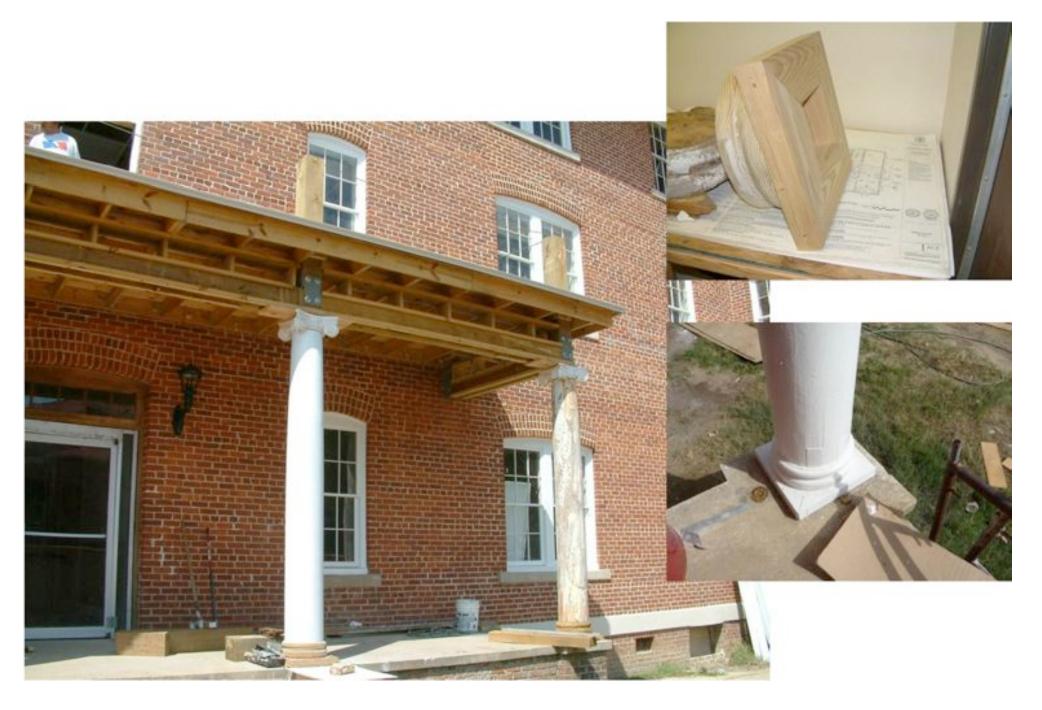
**Wood Columns – Bases Installed**

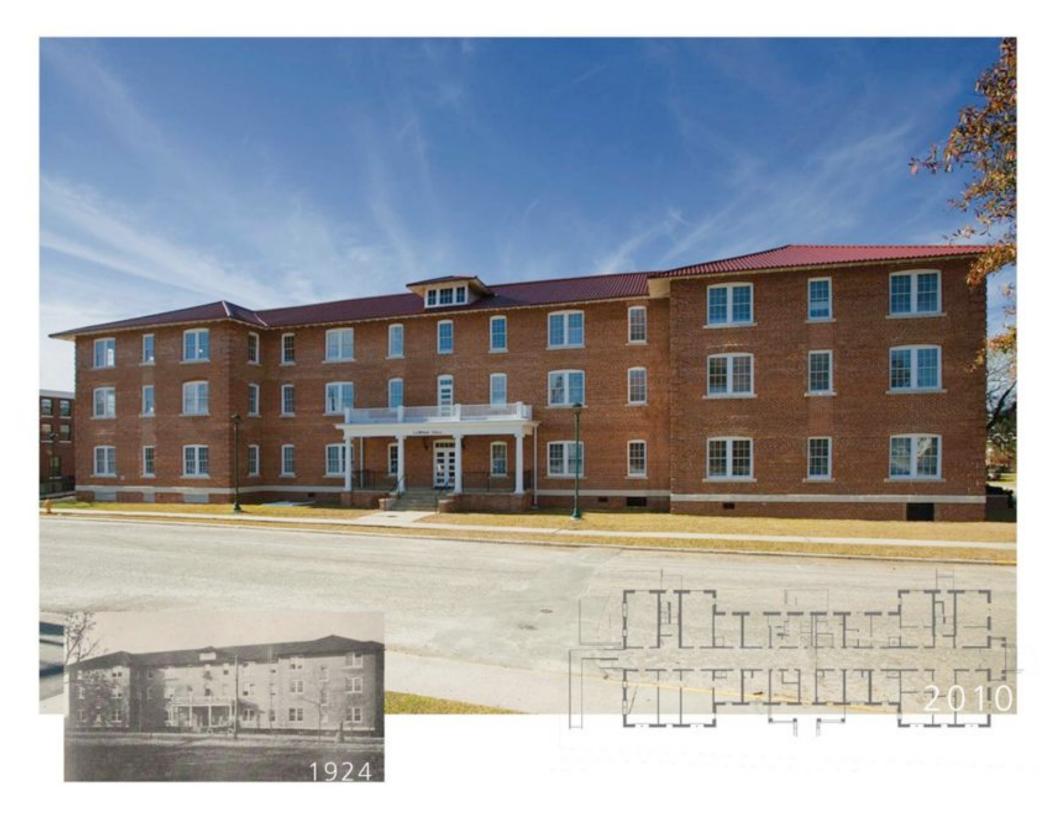
2004 2010

① Roofing returned to original "terra cotta" profile. ② Original windows restored & rebuilt. Interior glazed storm windows introduced to improve thermal efficiency. ③ Steel dowels embedded in horizontal masonry joints to stabilize severe settlement and buckling due to previous structural damage. ④ Non-original window and masonry patch replaced with historically accurate French doors. ⑤ Historically accurate balustrade rebuilt. ⑥ Side entry portico rebuilt based upon photos of front entry and salvaged members at side entry.
